Documenta Ophthalmologica 64:143–152 (1986)

Degradation of polypropylene in the human eye: A sem-study

W.L. JONGEBLOED¹ and J.F.G. WORST²

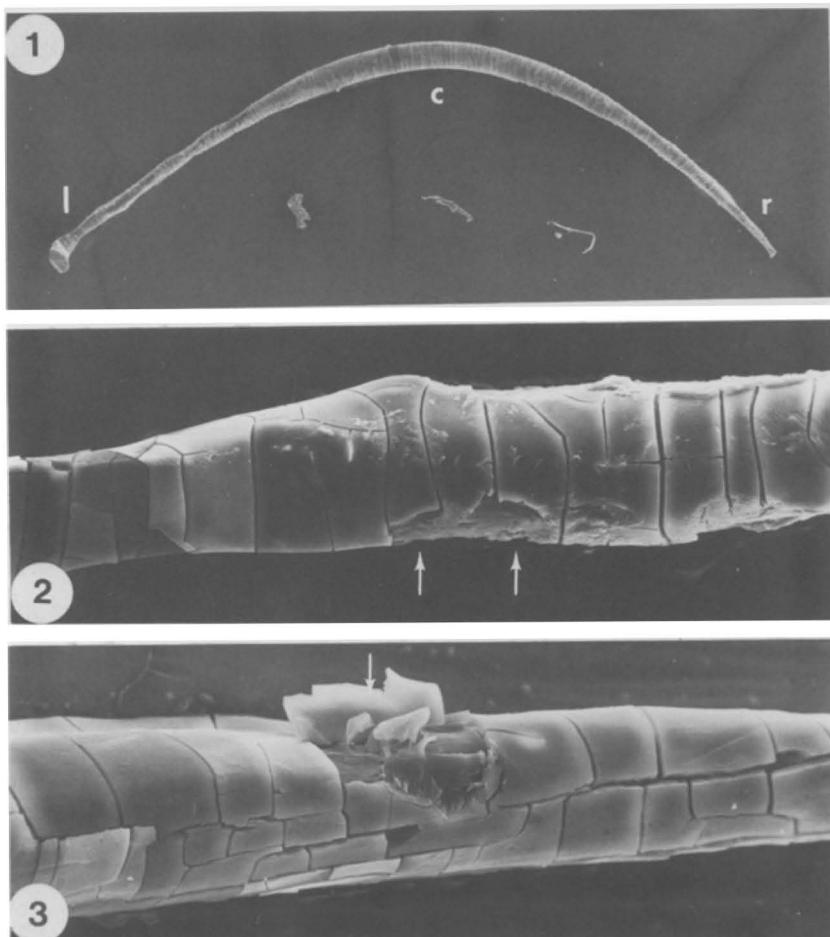
The polypropylene suture which had been in the human eye for $6\frac{1}{2}$ years as fixation suture for an IOL is shown at low magnification in Figure 1. The left end (l) and the right end (r) of the suture show a considerable decrease in suture diameter in comparison with the central part (c). The right end had spontaneously broken, while the left end was cut off to free it from the surrounding tissue.

Figures 2 and 3 represent parts of the left side of the suture, cracks perpendicular to the longitudinal axis of the suture are visible. Lumps of the surface layer are nearly detached or are already missing (arrows). Note also the irregularity of the diameter of the suture in both pictures.

Figure 1. Polypropylene suture which remained for $6\frac{1}{2}$ years in a human eye as a fixation suture; l = cut-off end, diameter appr. $100 \mu\text{m}$; r = spontaneously broken off end, diameter appr. $60 \mu\text{m}$; c = central part, not in direct contact with tissue, diameter $200 \mu\text{m}$. Magn. $20 \times$.

Figure 2. Part of left side of suture of Figure 1, showing cracks in surface layer and missing part of surface layer (arrows); note irregular diameter. Magn. $225 \times$.

Figure 3. Part of left side of suture of Figure 1, showing cracks in surface layer and nearly detached lump of surface layer (arrow); note somewhat twisted shape of suture. Magn. $325 \times$.

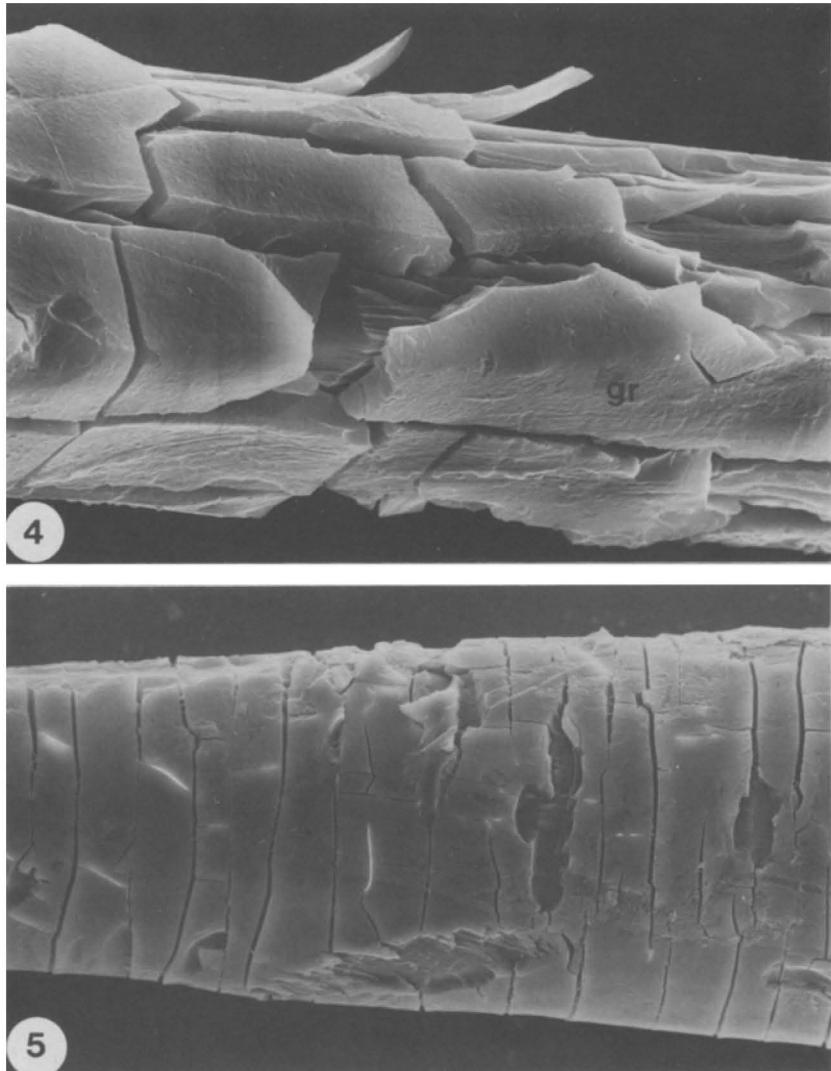
Figures 4 and 5 also represent parts of the left side of the used suture of Figure 1. The cracking of the surface layer is very obvious in Figure 4; almost the complete surface layer has been split off from the underlying layer. The outer surface of the lumps is covered with a thin layer of probably organic material with a slightly granular appearance (Figure 4). Closer to the central part of the suture (the part which was not in direct contact with the tissue) the disintegration of the polypropylene appears to be considerably less extensive. Figure 5 represents a part of the suture left of the centre, the cracks in the surface layer are already present and the diameter decreases towards the left side of the suture.

Figure 4. Part of left side of suture of Figure 1 showing completely disintegrated surface layer, large lumps nearly detached. Magn. 1000 \times .

Figure 5. Part of left side of suture of Figure 1, close to central part of suture. Surface less attacked; note decreasing diameter towards left side. Magn. 300 \times .

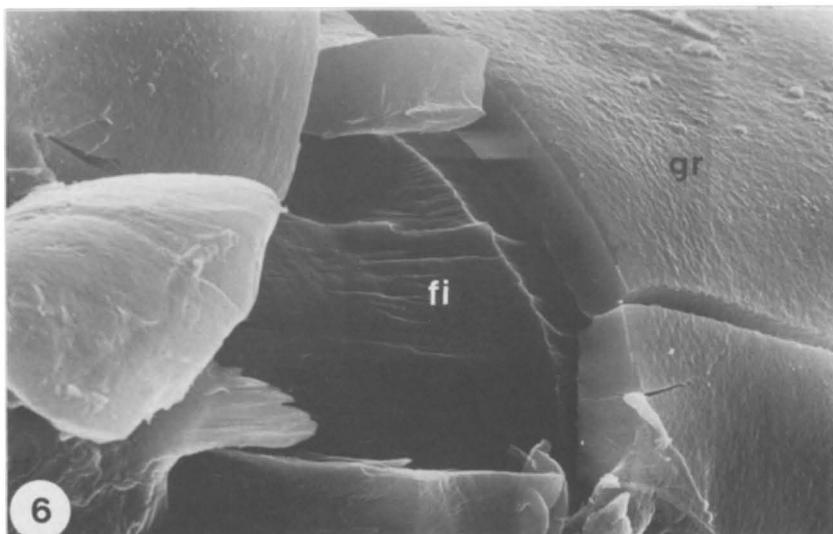
Figures 6 and 7 represent details of Figures 3 and 4 respectively, showing the subsurface layer after splitting off of the lumps of the surface layer. The subsurface layer shows a fibrillar character and the splitting off

Figure 6. Detail of Figure 3 showing subsurface layer with fibrillar character (fi); note thin organic deposit with granular character (gr) on outside of lumps of surface layer. Magn. 2000 \times .

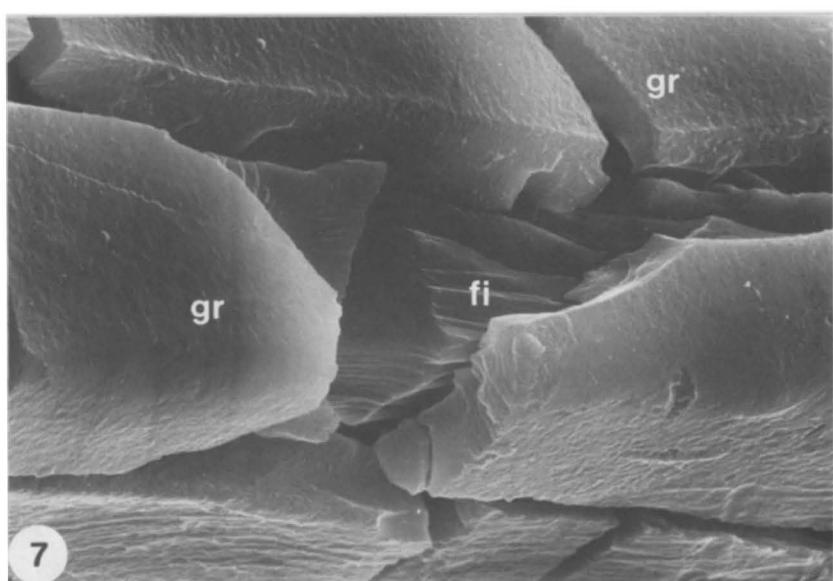
Figure 7. Detail of Figure 4 showing splitting of surface layer from underlying layer with fibrillar appearance (fi); lumps covered with somewhat granular material (gr). Magn. 2000 \times .

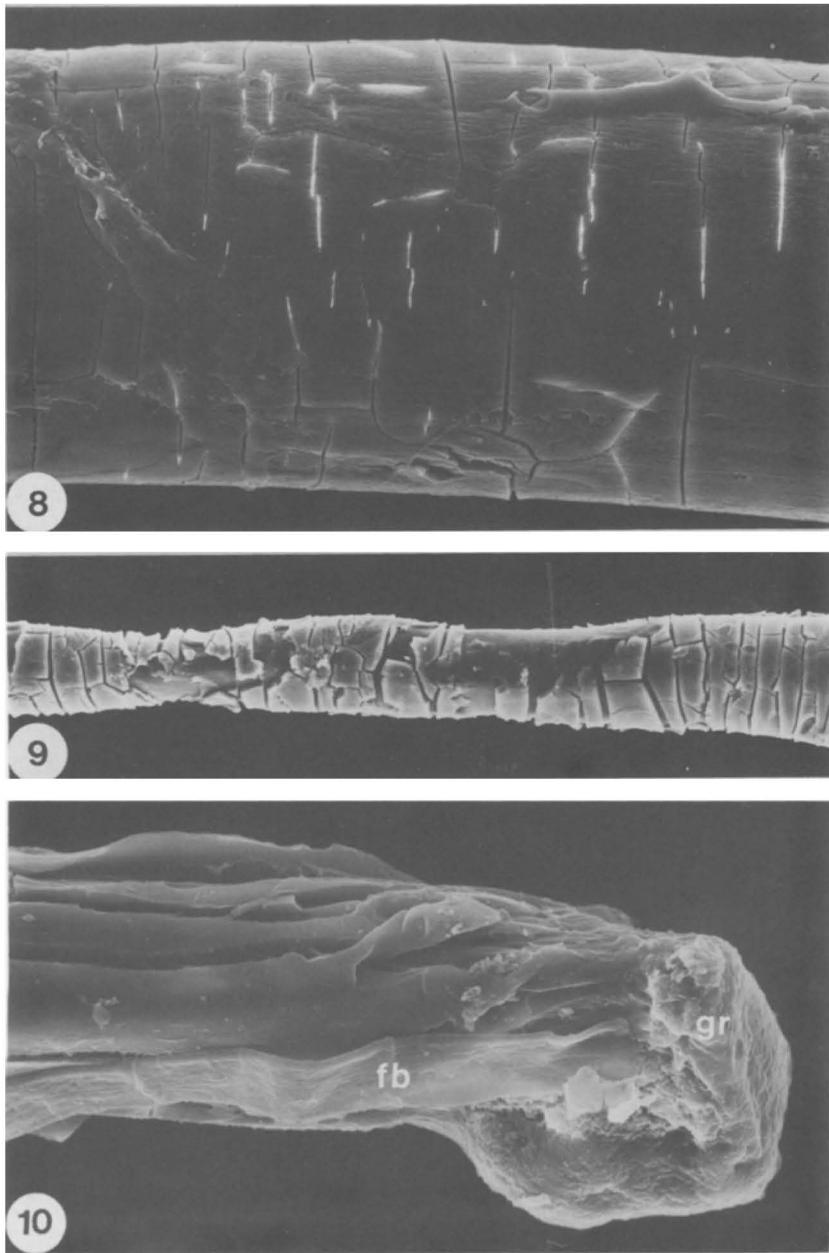
Figure 8 represents the central part of the suture, some cracks in the surface are already visible and some deposition of material. The diameter

still has its original value of 200 μm . Figures 9–13 represent sections of the right side of the suture of Figure 1.

Figure 9 shows the irregular diameter and the splitting off of parts of the surface layer, at low magnification.

Figure 8. Central part of suture of Figure 1, which was not in contact with tissue. Some cracking of surface layer present; diameter $200 \mu\text{m}$. Magn. $300\times$.

Figure 9. Part of right side of suture of Figure 1 at low magnification showing irregular diameter and cracking of surface layer. Magn. $120\times$.

Figure 10. Spontaneously broken end of suture of Figure 1 showing granular deposit (gr) and fibre-like material (fb) at the tip. Magn. $600\times$.

The spontaneously broken-off end of the suture, the actual reason for removal from the eye, is shown in Figure 10. The end of the surface is covered with slightly granular material and rather long strands of fibrillar material.

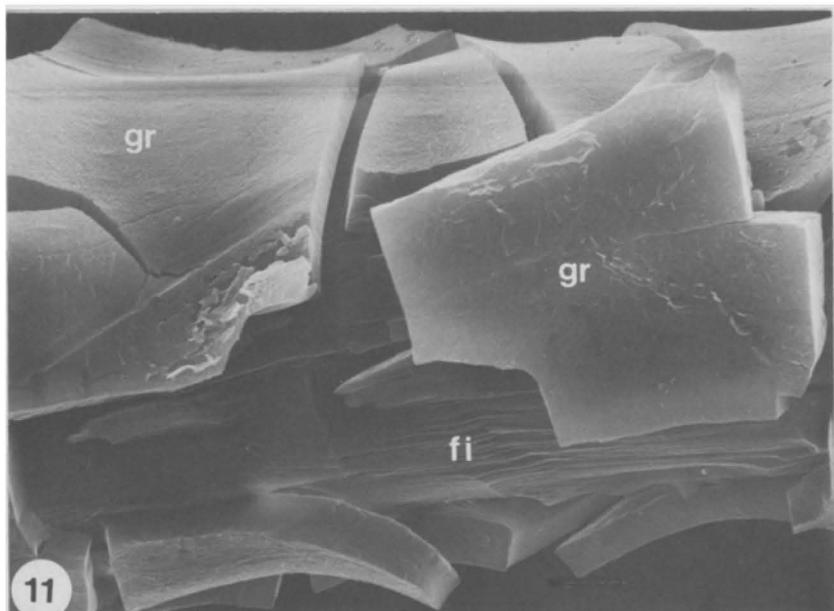
Figure 11 shows the destruction of the polypropylene in a rather dramatic way; the complete surface layer has broken into pieces, exposing the subsurface layer. The outside layer is covered with some deposits, mainly of a granular nature.

Figure 11. Part of right side of suture of Figure 1 showing almost complete degradation of surface layer, large lumps have detached exposing subsurface layer with fibrillar character (fi). Note granular deposit on lumps (gr). Magn. 975 \times .

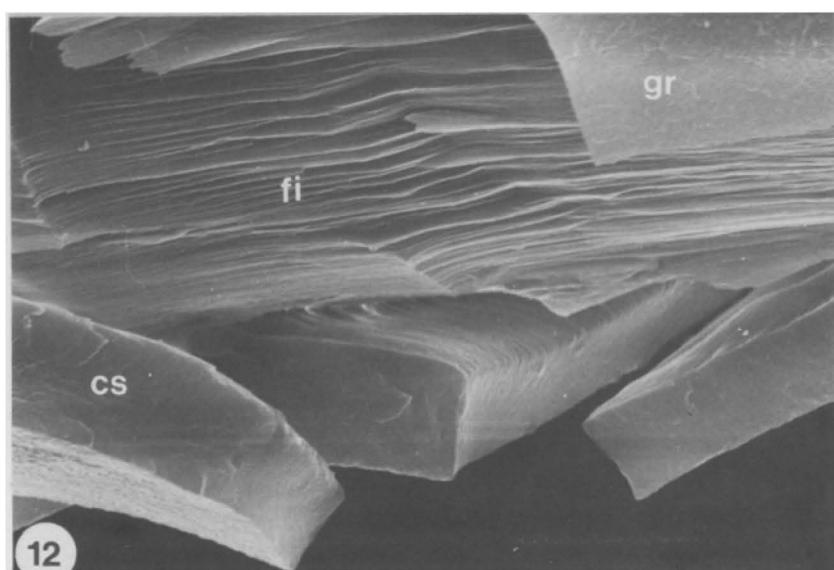
The subsurface layer is observable in more detail in Figure 12 (detail of Figure 11); the fibrillar character of this layer is clearly visible, while the splitting of the surface layer is noticeable, particularly at the cross-sections of the split-off lumps in the lower part of the picture.

Figure 12. Detail of Figure 11 showing subsurface layer (fi) and split-off lumps of surface layer in more detail (cs). Magn. 2500 \times .

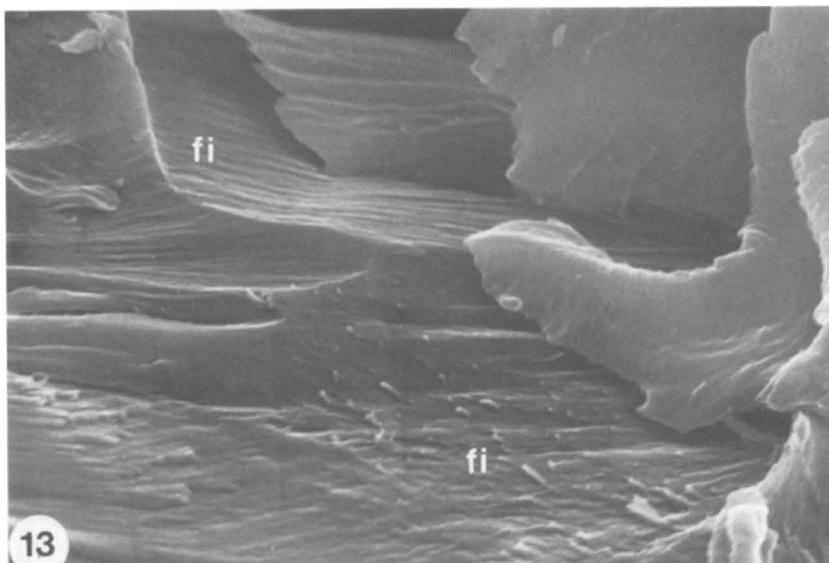
The fibrillar character of the subsurface layer, and the irregular splitting of the surface layer from the underlying layer as the result of a chemical change in the surface layer, are shown in more detail in Figure 13.

Figure 13. High magnification of subsurface layer after detachment of surface layer; note irregular splitting effect due to chemical change in polypropylene. Fibrillar character (fi) of subsurface layer clearly observable. Magn. 5000 \times .

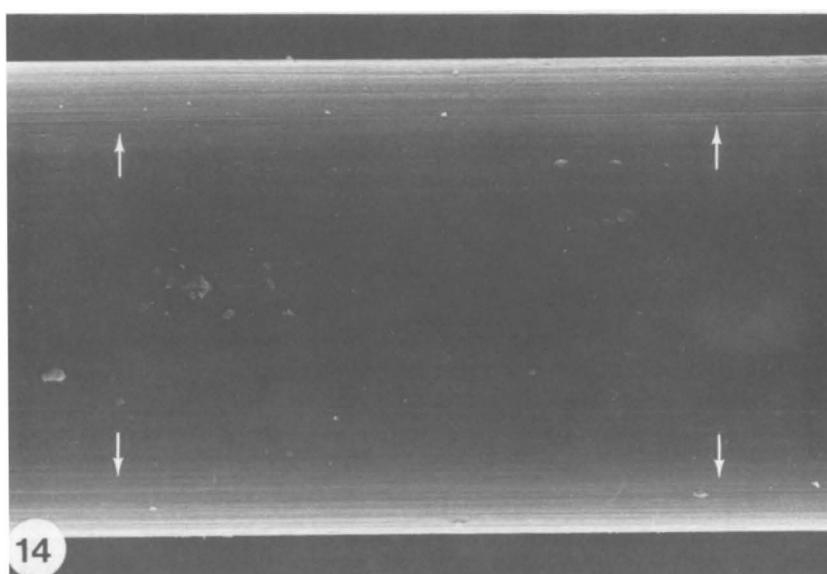
In a virgin piece of surgical polypropylene, taken from an intact package, none of the phenomena described above are observable (Figure 14). The diameter is 200 μm and only thin grooves due to the manufacturing process are visible running along a very smooth surface (arrows).

Figure 14. Virgin piece of polypropylene from a surgical packet, prepared for SEM in exactly the same way as the suture of Figure 1, showing no degradation at all; note manufacturing grooves (arrows). Magn. 300 \times .
